Manhole Inspection Summary

Manhole # S21II_039MH

Insp Date: **3/4/09 9:40 AM**

Location Address: **N MOUNT ST**

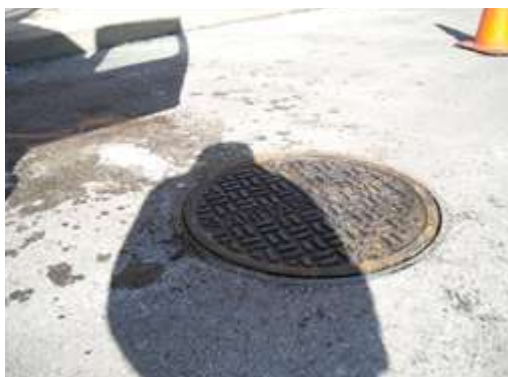
NEW LID

REPLACED OLD LID WITH NEW 24" SANITARY LID

Comments **OBSERVED STUCK VENTED STORM DRAIN COVER. BROKE AND REPLACED LID WITH NEW 24" SANITARY LID BY REI/DRAYCO. INSPECTION COMPLETE.**

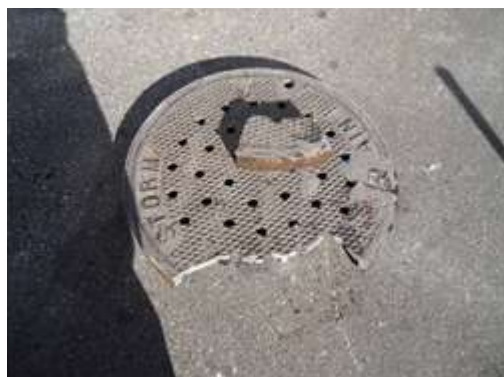
PREVIOUS LID

PREVIOUSLY HAD VENTED STORM DRAIN LID - BROKE AND REMOVED

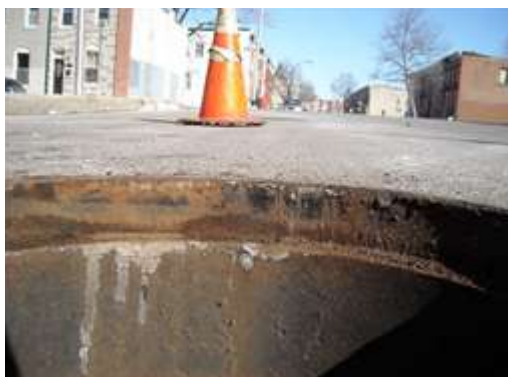
EVIDENCE OF SHEETING FROM CROWN OF ROADWAY

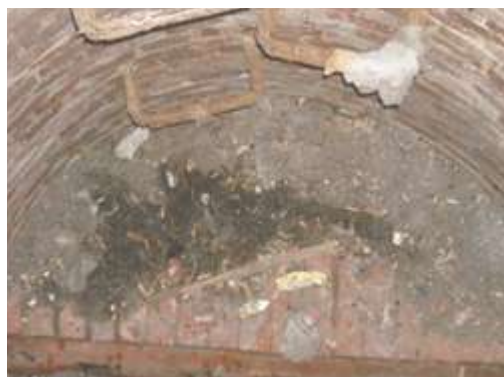
Defect 5

DEBRIS ON BENCH

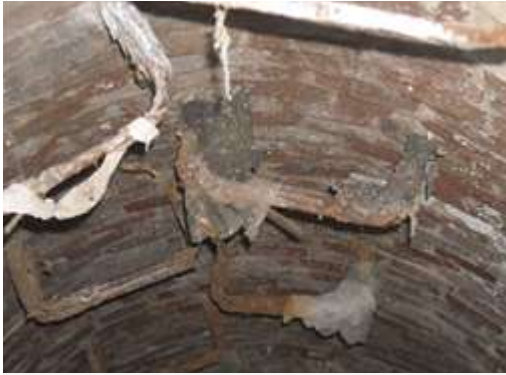
Defect 4

Surcharge ☒ Evidence Of Surcharge Depth: **6** (ft.) ☐ Active Surcharge Present

EVIDENCE OF SURCHARGE AT 6 FEET

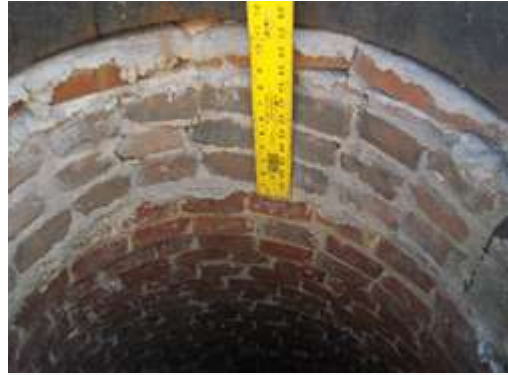
Defect 3

12" BRICK AND CONCRETE CHIMNEY
ADJUSTMENT

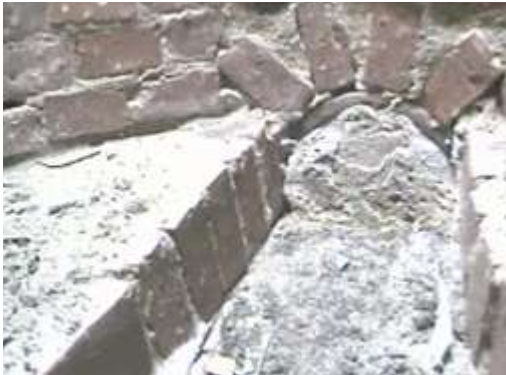
Defect 2

CAPPED 9 OCLOCK SERVICE LINE

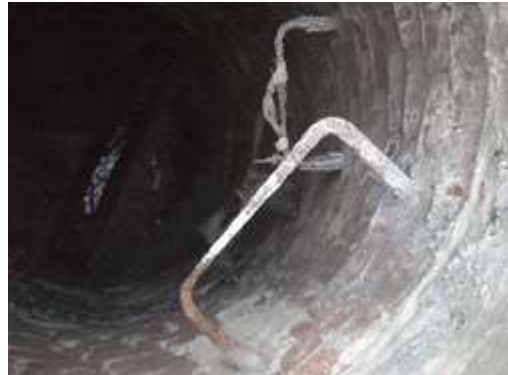
Defect 1

Steps Count: **6** Missing: **0** ☒ Corroded

CORRODED STEPS

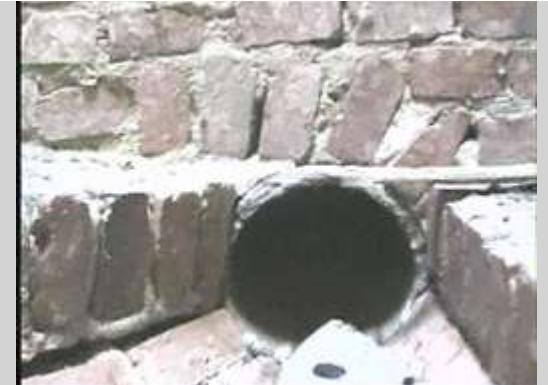
12 O'Clock Outflow

Pipe Height: **10.8** (in.) Rod and Bar (Angled)
Pipe Material: **Clay** ☐ Pipe Lined
Invert Depth: **10.24** (ft.) Flow Characteristics: **Slow**
Deposits: ☒ None ☐ Mud ☐ Sludge ☐ Debris ☐ Grease
Silt Depth: (in.) Deposits Extent:
Infiltration: **None** Pipe Seal Cond: **Sound**

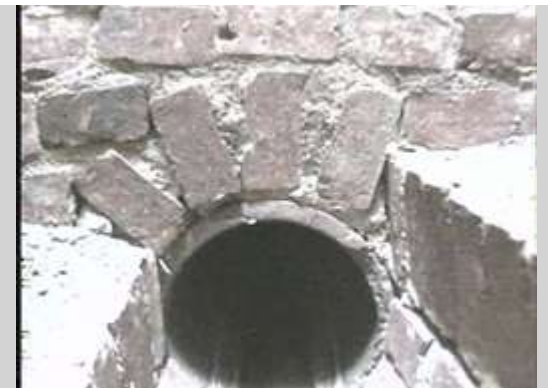
6 O'Clock Inflow

Pipe Height: **10.8** (in.) Rod and Bar (Angled)
Pipe Material: **Clay** ☐ Pipe Lined
Invert Depth: **10.17** (ft.) Flow Characteristics: **Slow**
Deposits: ☒ None ☐ Mud ☐ Sludge ☐ Debris ☐ Grease
Silt Depth: (in.) Deposits Extent:
Infiltration: **None** Pipe Seal Cond: **Sound**
